**DRAFT FINDING OF NO SIGNIFICATION IMPACT AND
ENVIRONMENTAL ASSESSMENT
for the
BOSQUE WILDFIRE PROJECT,
BERNALILLO and SANDOVAL COUNTIES, NEW MEXICO**

**Prepared by:
U.S. Army Corps of Engineers, Albuquerque District,
4101 Jefferson Plaza NE, Albuquerque, New Mexico 87109**

**DRAFT ENVIRONMENTAL ASSESSMENT FOR THE BOSQUE WILDFIRE
PROJECT, SANDOVAL AND BERNALILLO COUNTIES, NEW MEXICO**

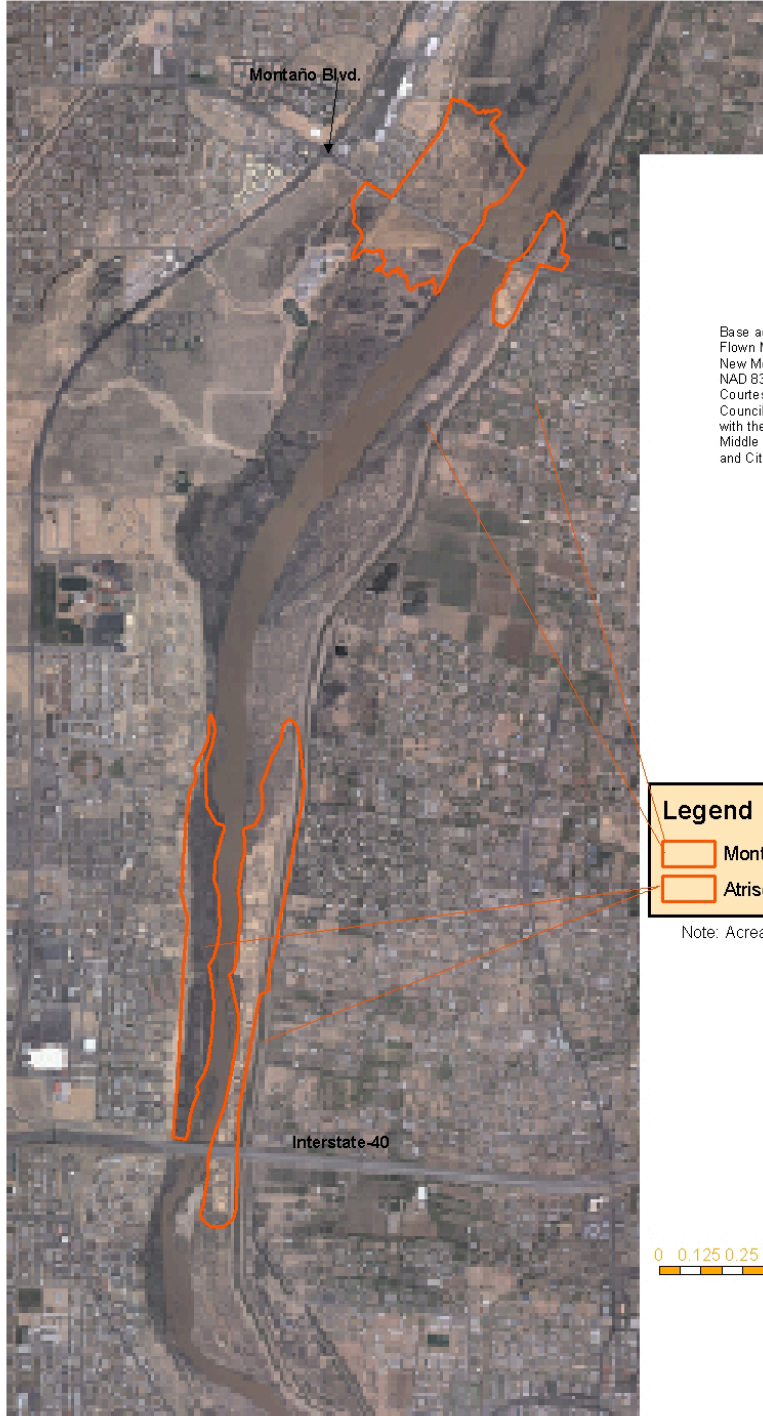
- Removal of 675 jetty jacks and 950 dead stumps in the areas that were burned in 2003 (shown in Figure 1) which was documented in the “Supplemental Environmental Assessment to the Middle Rio Grande Bosque Jetty Jack Removal Evaluation Study Environmental Assessment, April 2004” (USACE, 2004a) and
- The installation of 3 temporary emergency drain crossings and emergency levee road rehabilitation which was documented in the “Supplemental Environmental Assessment for Temporary Emergency Bridges and Levee Operations and Maintenance, Bosque Wildfire Project, City of Albuquerque, Bernalillo County, New Mexico, June 2004” (USACE, 2004b).

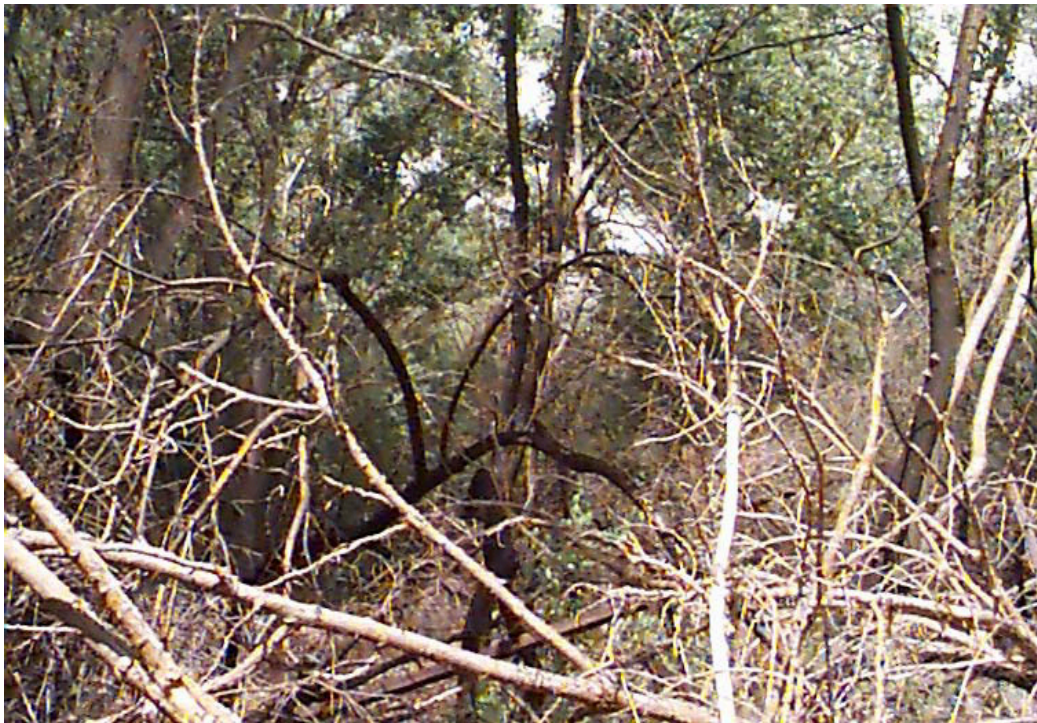
FIGURE 6. EXAMPLE OF DEAD AND NON-NATIVE VEGETATION PILED.

The overall project goals include reducing fuel loads and thinning of non-native vegetation. Both can be considered unsightly and also create a 'cluttered' bosque. Views into and through the bosque are currently not possible where vast amounts of non-native vegetation and dead material exist piled up on top of each other (Figure 6). Thinning of this vegetation as well as removal of jetty jacks would allow for increase views through the bosque, which would aid in safety as well as increase aesthetics. The 'view' of the bosque would improve for the public using the trail system. Therefore, there would be long-term beneficial effects to aesthetics in the bosque for the public.

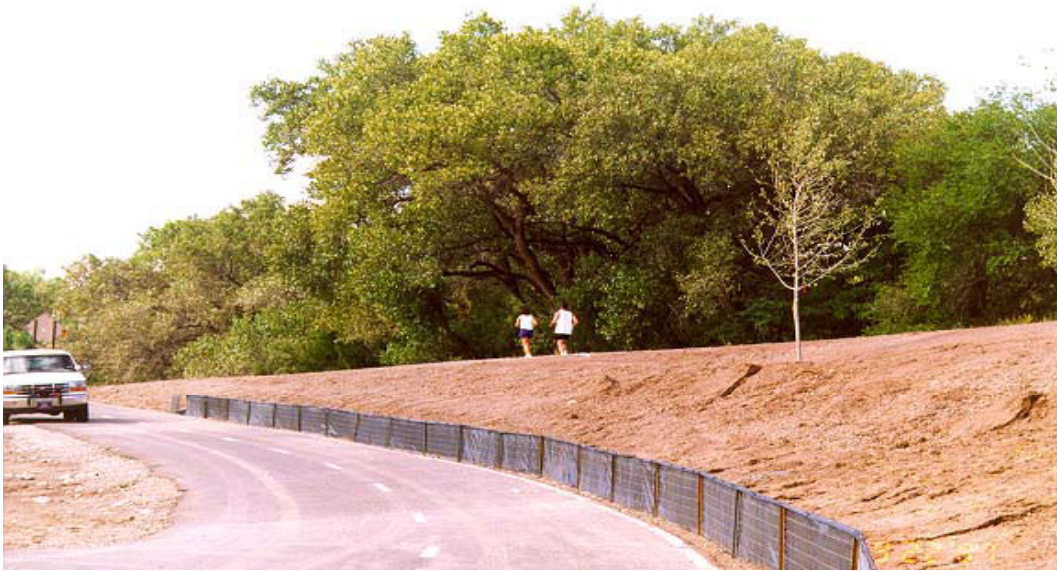
FIGURE 7. PASEO DEL BOSQUE (PAVED TRAIL) IN THE RGVSP.

Within the RGVSP, a paved trail along the east side of the river exists along the levee from Alameda Blvd. south to south of Rio Bravo Blvd. (approximately 18 miles in length, see Figure 7). Trails within the bosque exist on both sides of the river in the RGVSP and are a natural surface (in most cases dirt though in some cases a formalized crusher fine trail has been constructed). Various levels of recreation take place on the paved trail including jogging, bicycling, roller blading and walking. On the natural surface trails (Figure 8) jogging and walking take place but mountain biking and horseback riding are also favorite uses. No motorized vehicles except for maintenance and emergency vehicles are allowed per City of Albuquerque and Bernalillo County ordinances.

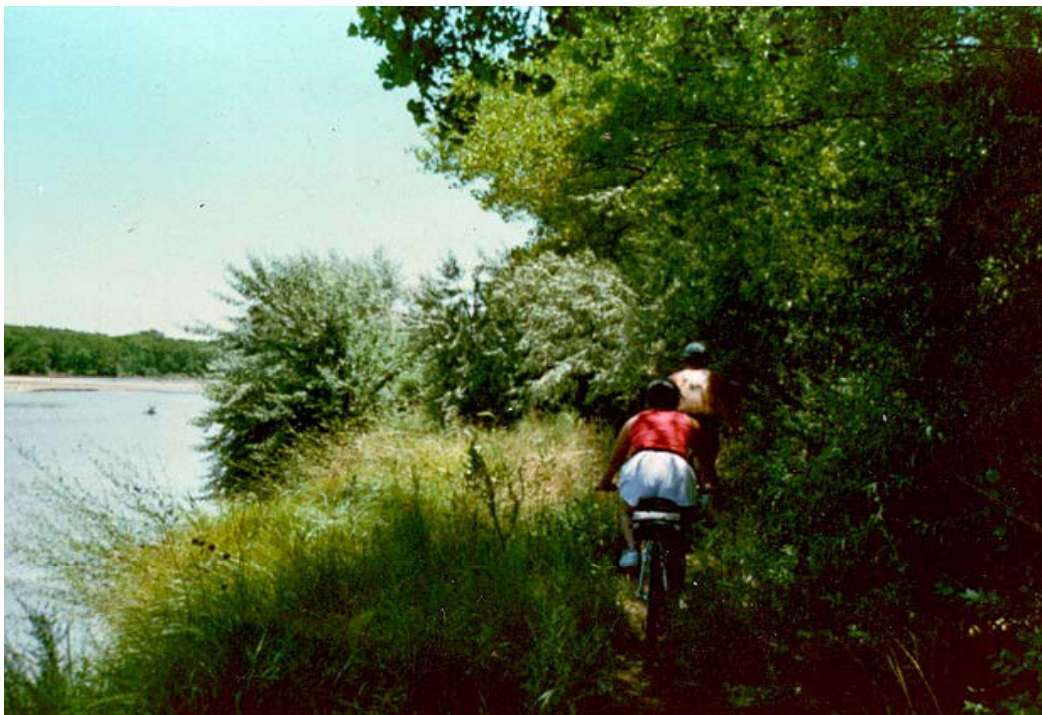
FIGURE 8. EXAMPLE OF NATURAL SURFACE TRAIL IN THE BOSQUE.
